Manhole Inspection Summary

Manhole # S35WW_021MH

Location Address: **307 30TH ST**

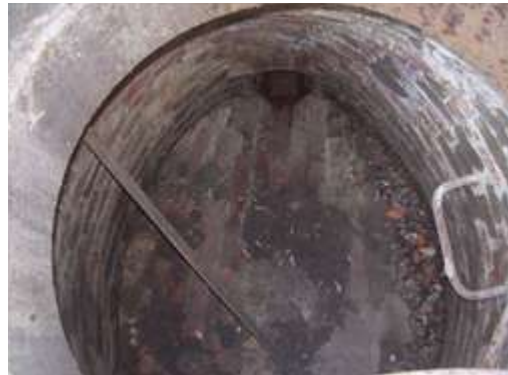
Top View

Channel debris.

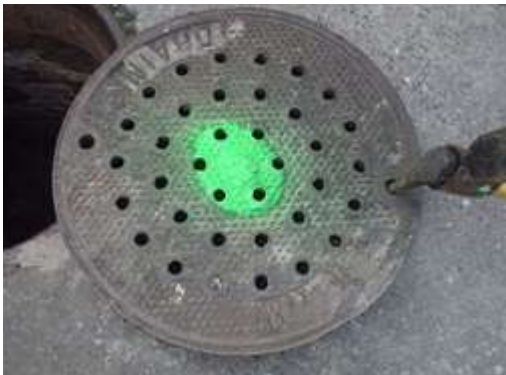
Storm Drain lid

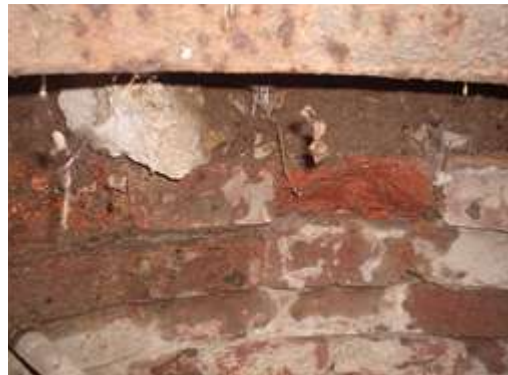
Defect

Condition: ☐ Sound ☐ Cracked ☐ Root Intrusion ☐ Loose Brick ☒ **Deteriorated**

Infiltration: ☐ None ☐ Joint ☐ Cracks ☐ Mortar ☐ Roots ☒ **Wall**

Frame leaks. Adjustment deterioration and infiltration.
